# FRCM Strengthening of the Buttresses

## The Aghlabid Basins, Kairouan, Tunisia

Structural Strengthening

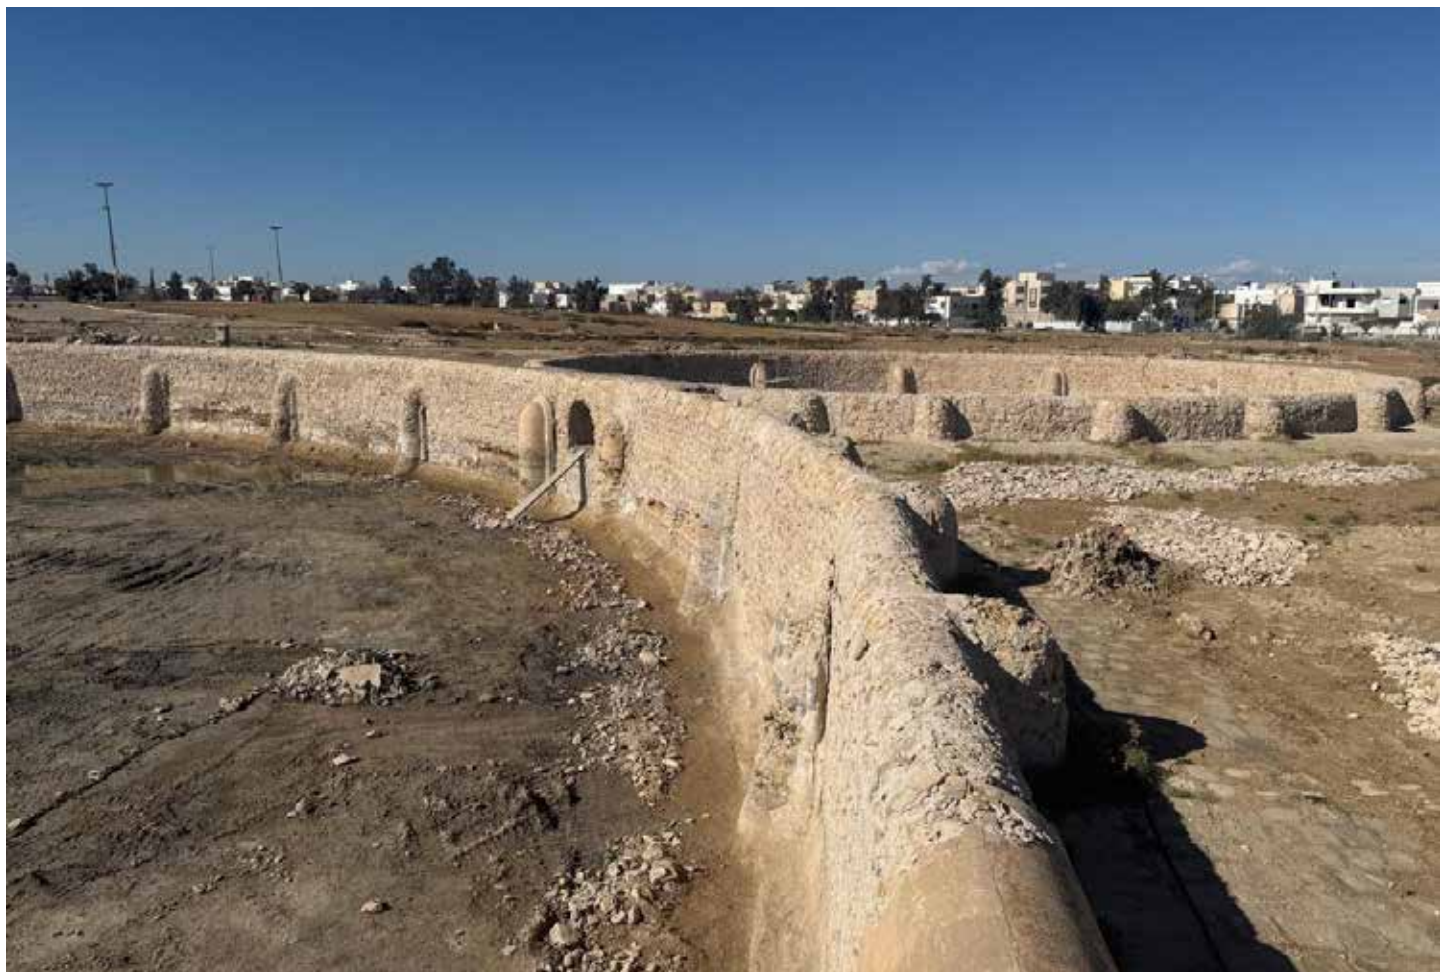
Removal of the original lime-based render.

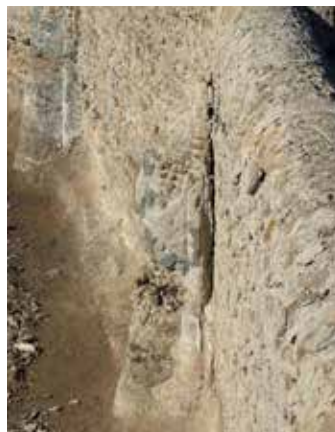
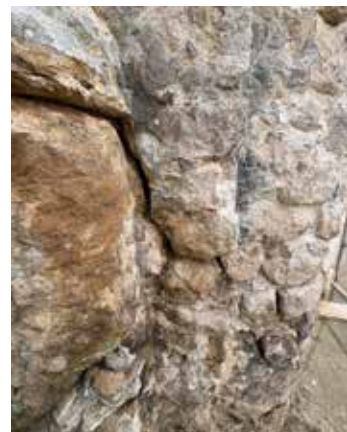
Structural investigations identified diagonal cracking affecting several masonry buttresses in both basins, requiring structural strengthening to restore their load-bearing capacity. The intervention had to remain fully compatible with the original lime-based masonry construction while minimizing its visual and physical impact on the historic fabric. To preserve the authenticity of the monument, the selected strengthening solution had to be cement-free, compatible with traditional lime-based materials, and designed as a minimally invasive system that could integrate seamlessly with future conservation work.

Condition of buttresses showing diagonal cracks.

To satisfy the demanding conservation and structural requirements of this UNESCO World Heritage Site, Sika developed a mineral-based FRCM (Fabric Reinforced Cementitious Matrix) strengthening system combining Sika CarboDur®-300 Grid, SikaEmaco® S 285 TIX, and SikaWrap® FX-50 C.

The strengthening system consists of Sika CarboDur®-300 Grid embedded within the cement-free, lime-based repair mortar SikaEmaco® S 285 TIX. The system is completed using SikaWrap® FX-50 C carbon fibre strands, providing mechanical anchorage of the grid and ensuring efficient load transfer throughout the masonry.

In total, 20 internal buttresses and one masonry vault required structural strengthening. The reinforcement was applied across the full width of each buttress, extending approximately 50 cm beyond each side of the wall over a height of approximately 2.5 m, ensuring effective stress redistribution and confinement of the cracked areas. The strengthened vault covered an area of approximately 12 m<sup>2</sup>, resulting in a total treated surface of approximately 250 m<sup>2</sup>.

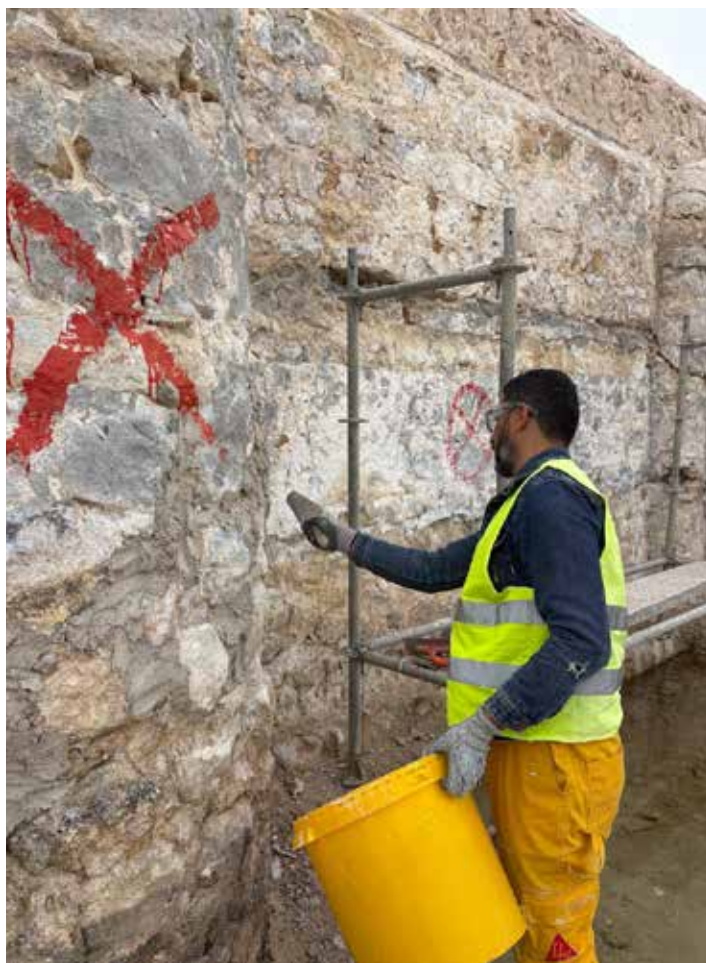
Application of the Sika CarboDur®Grid+ SikaEmaco®S 285 TIX System.

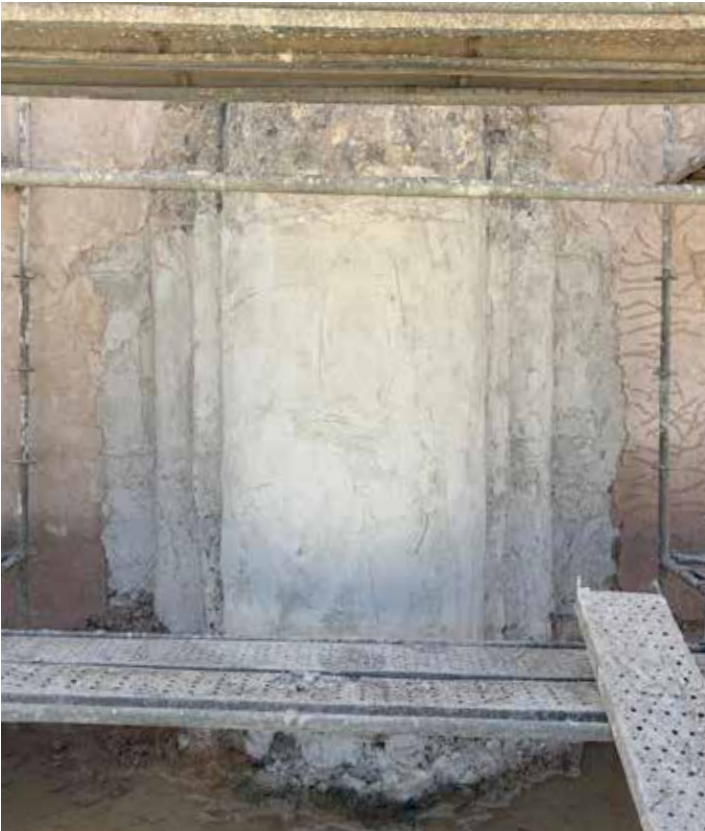
Completed strengthening system with SikaWrap® FX-50 C.
